TP 14366E

Tank-Car Thermal Protection Defect Assessment: Fire Tests of 500-Gallon Tanks with Thermal Protection Defects

Department of Mechanical and Materials Engineering
Queen's University
Kingston, Ontario

March 2005

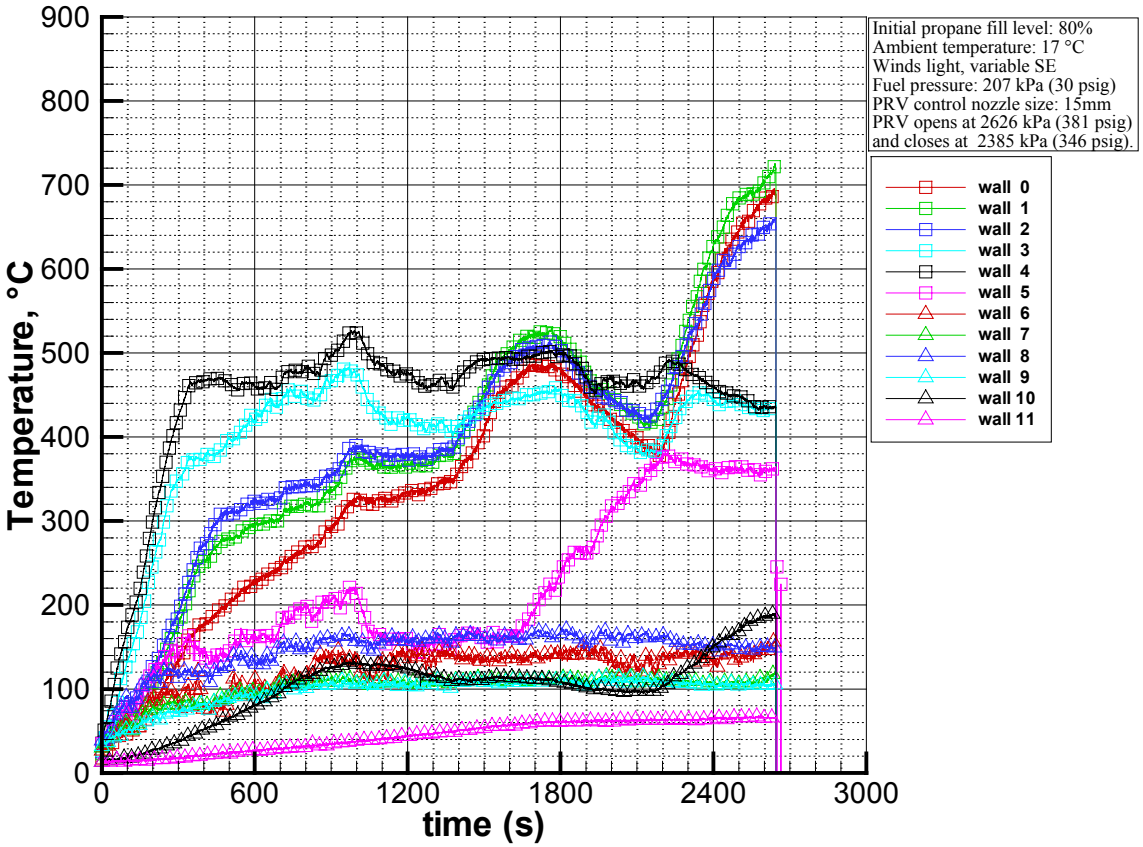
Figure 4.6: Wall temperature, Test 04-1 (baseline test, no insulation, no steel jacket, 78% fill)

Since the tank failure was at a wall temperature well above 700°C, it is believed the SA 455 steel in the tank was much stronger than the minimum ratings.

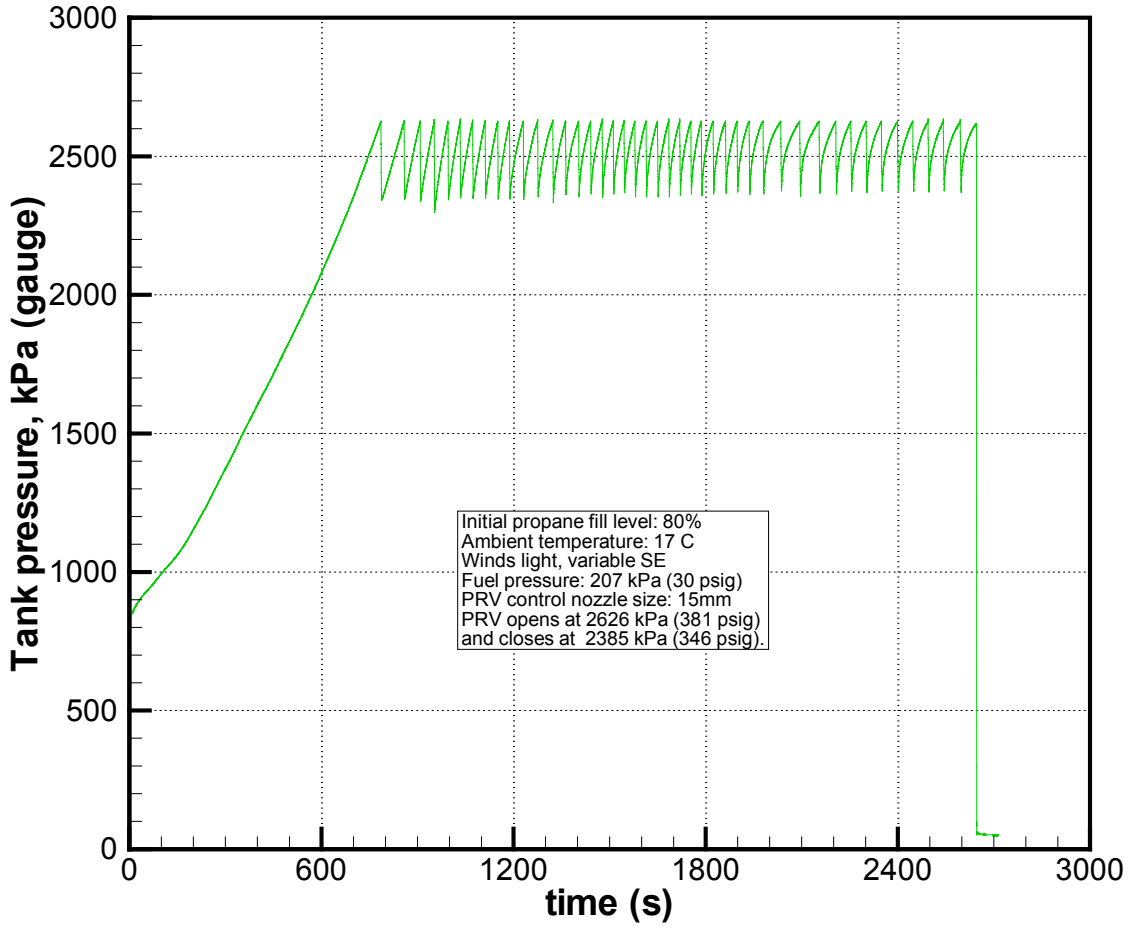
Figure 4.8: Tank pressure, Test 04-1

The PRV opened for the first time at 800 seconds (13.3 minutes), as shown in Figure 4.8. This is much later than expected and was due to the poor wall heating. The PRV had been predicted to open in a 100% engulfment case in about 2 minutes. For a 25% engulfment case, it would be expected to open in about four times longer, or 8 minutes. The PRV was activated 44 times for about one to two seconds each time. This represents about 150-200 L of propane being vented. Therefore, the tank was still about 60-70% full at failure.

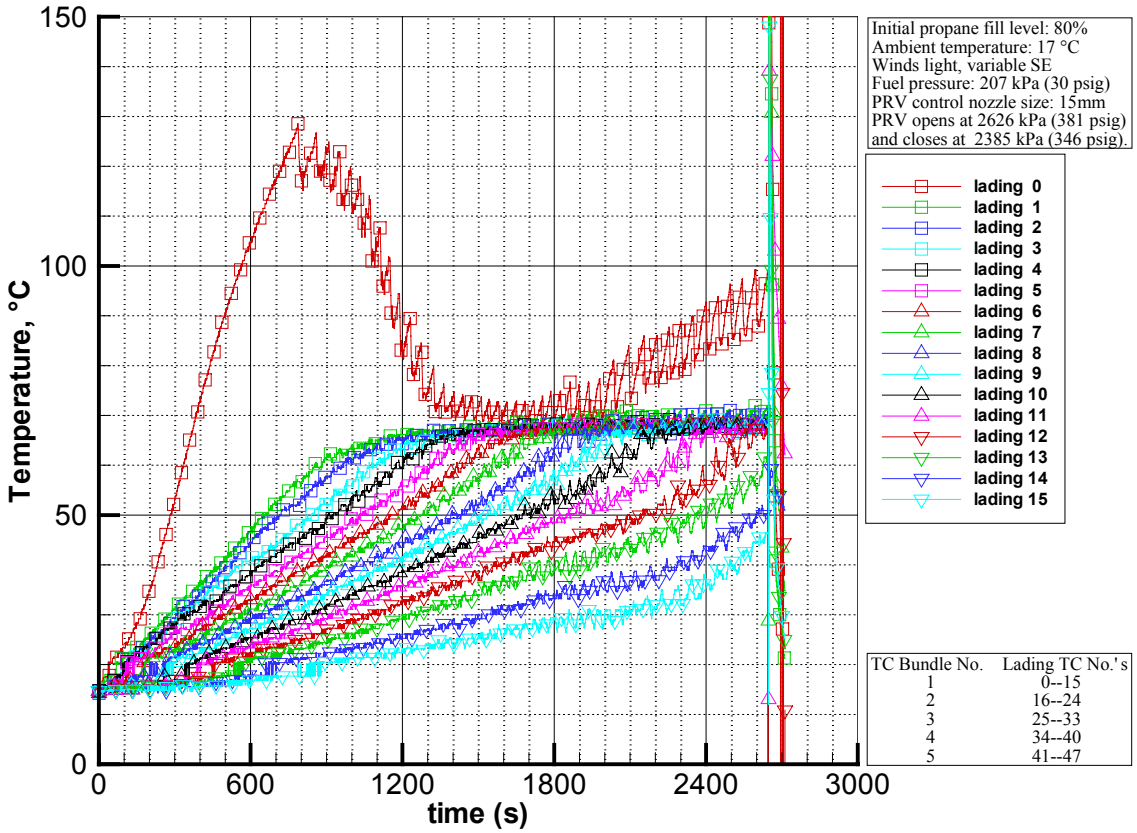
Figure 4.9: Lading temperature (TC bundle 1), Test 04-1

The liquid temperature was not de-stratified at the time of failure, as shown in Figure 4.9. Liquid temperature ranged from about 69°C at the liquid top to nearly 49°C near the bottom of the liquid. The peak vapour space temperature was 93°C.

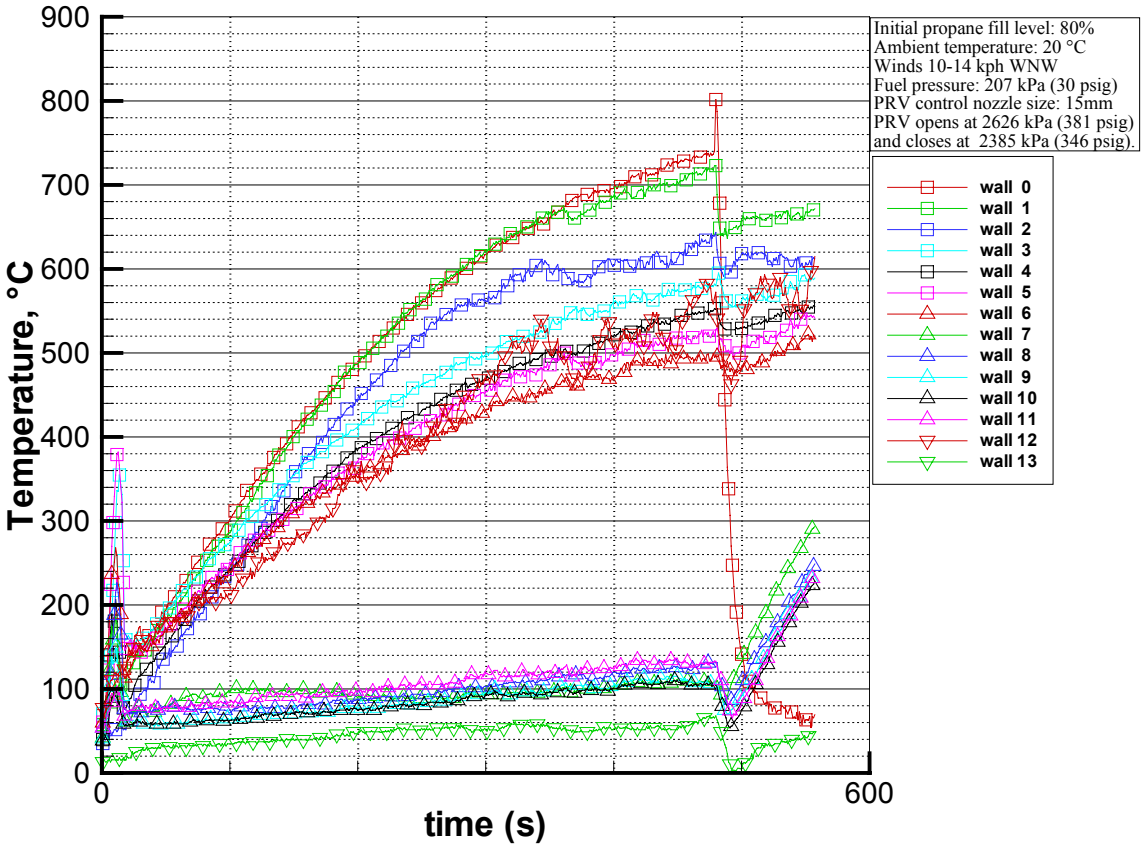
Figure 4.11: Wall temperature, Test 04-6 (baseline test, no insulation, no steel jacket, 78% fill)

Wind conditions were near ideal for this test, the best in the series. The fire was started and, as predicted, the tank failed with a large jet release in 8 minutes. Figures 4.12 and 4.13 show the tank and the failure opening. The failure tear length was 368 mm, with a maximum opening width of 45 mm and a vertical deformation from the top of the tank of 89 mm. Wall thinning was evident along the edge of the opening.

The PRV did not open over the course of the test. Tank pressure at failure was about 2.4 MPa (375 psig), very near the point of activating the PRV, Figure 4.14. Peak wall temperature was about 740°C. There was no BLEVE because the liquid lading was not

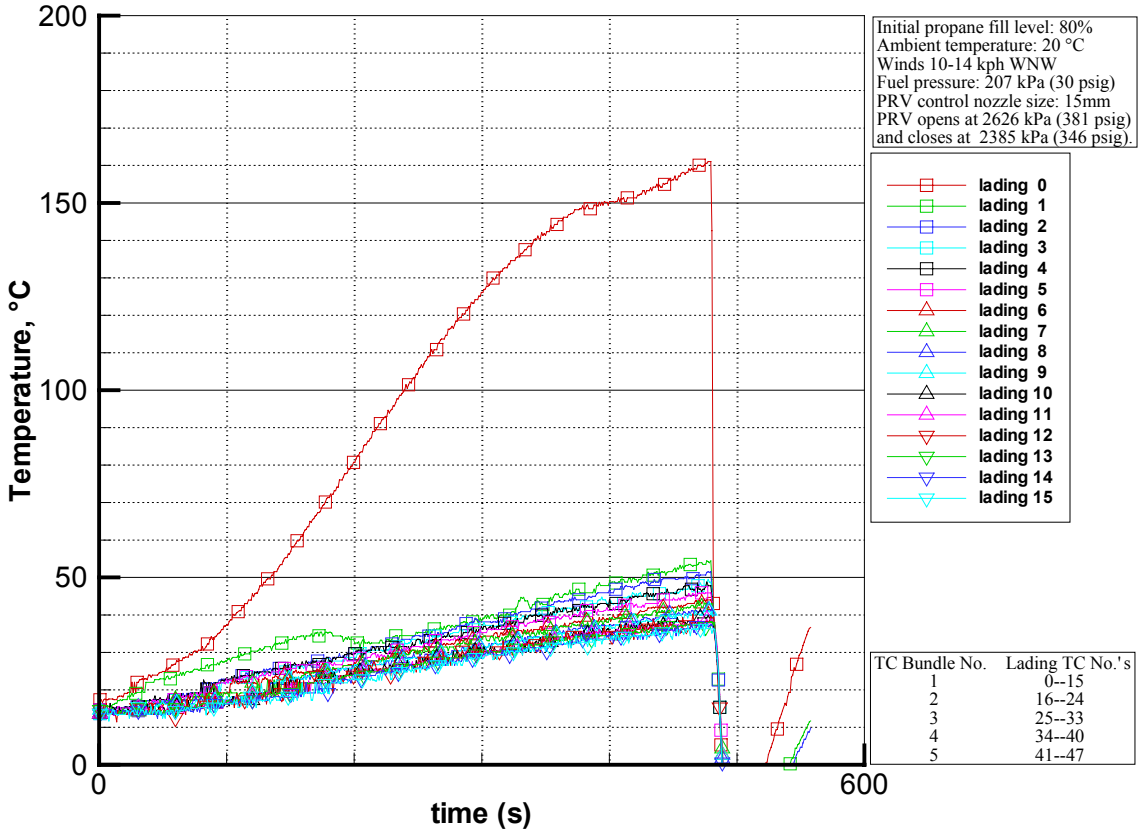
Because the failure was so rapid, the liquid temperature was not de-stratified at the time of failure, Figure 4.15. The liquid temperature ranged from 50°C at the liquid top to around 32°C near the liquid bottom. This reduced the energy available in the liquid to do work on the tank wall during the rupture process. The peak vapour space temperature was close to 160°C.

Figure 4.15: Lading temperature (TC bundle 1), Test 04-6

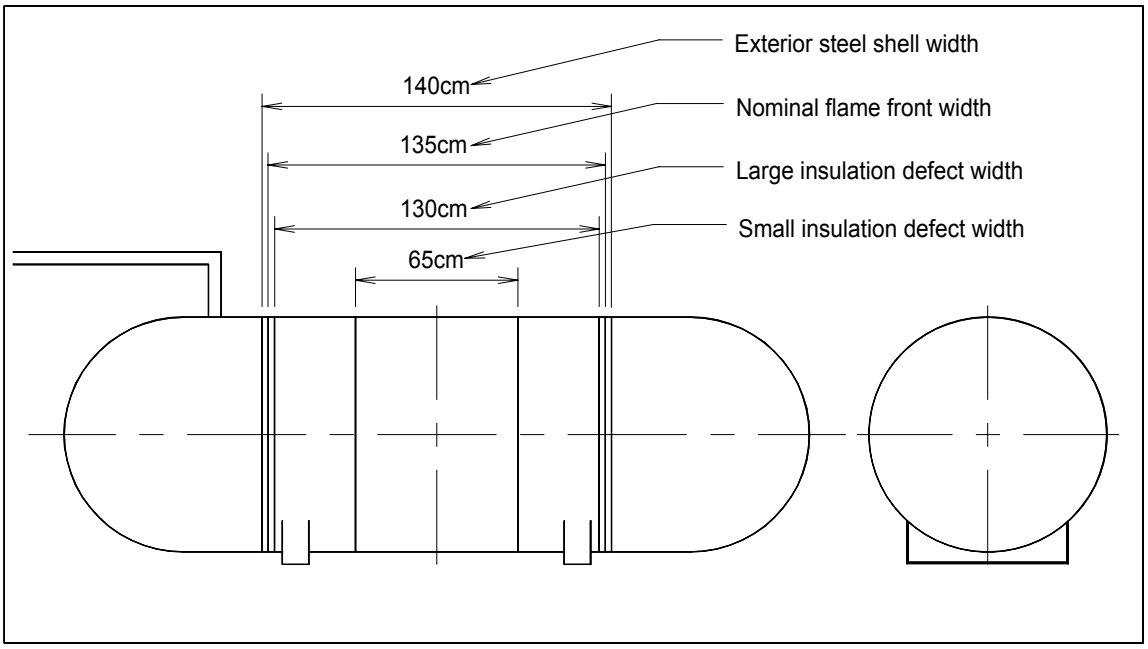
Figure 4.16 shows location and size of both large and small insulation defects and the protective steel jacket used. The large defect was 1.30 m wide and spanned almost the entire tank circumference except for the bottom 20-30 degrees. The remainder of the tank was insulated with 133 mm tank car ceramic fibre insulation. The white tank was painted black in the region of the defect to ensure a high emissivity.

Figure 4.16: Location and size of tank insulation defects and protective steel jacket

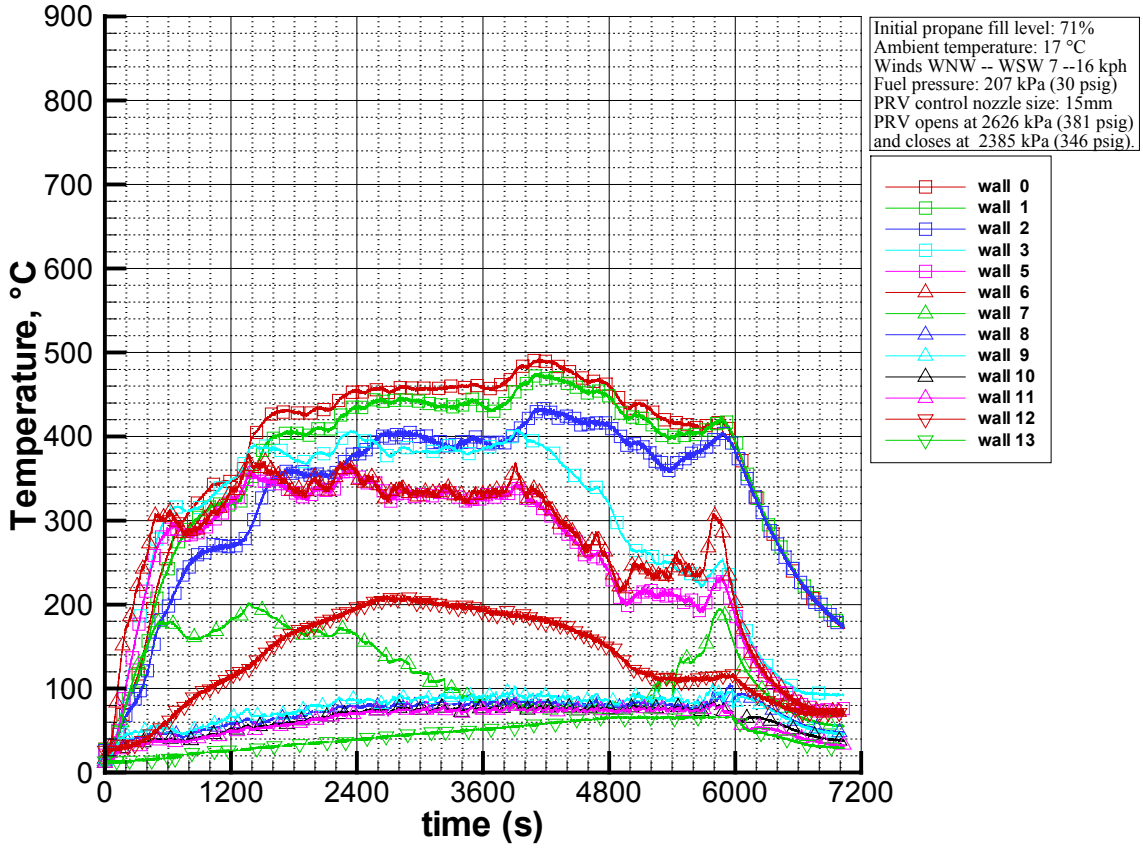
Figure 4.20: Wall temperature, Test 04-2 (16% area insulation defect, 71% fill). Run aborted due to insufficient burner fuel flow.

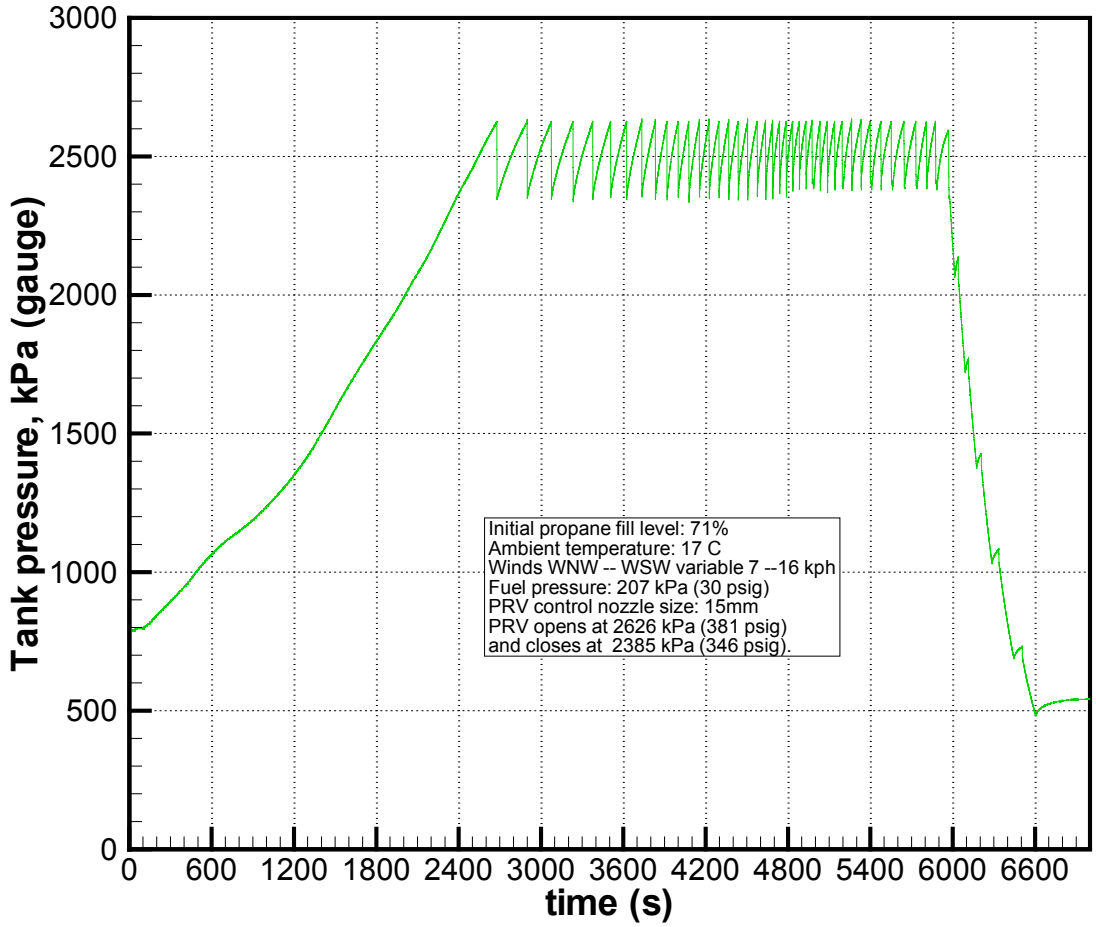
Figure 4.21: Tank pressure, Test 04-2

The PRV opened at 2700 sec and cycled 41 times before the test was stopped. The tank pressure was well controlled using the 15 mm PRV nozzle, Figure 4.21.

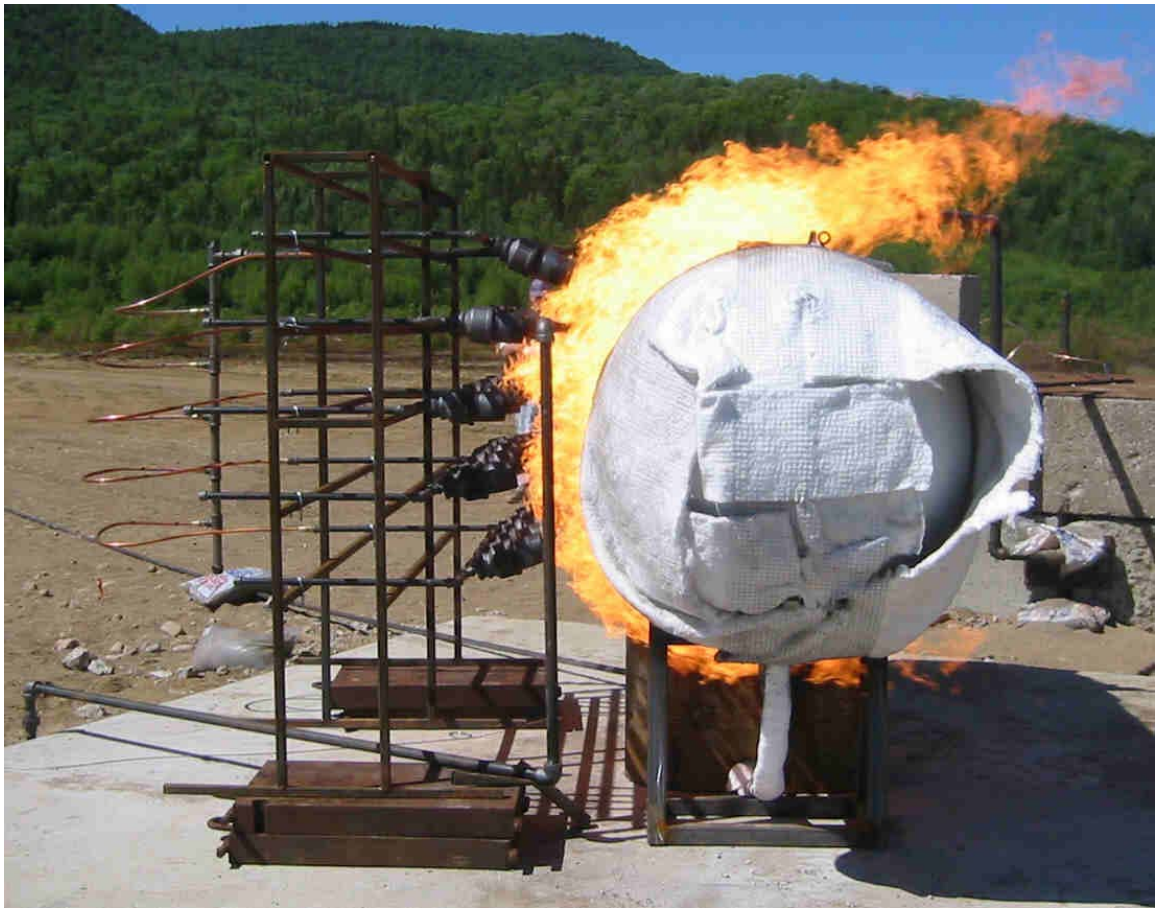
The tank from aborted Test 04-2, with the jacket and large defect, was filled to 50% with water. The portion of the burner fuel line consisting of 0.5 in. copper tube was replaced with 1 in. pipe to alleviate fuel flow restriction. The fire was started and it was immediately apparent that the fire condition had significantly improved, Figure 4.22.

Figure 4.22: Fire condition for Test 04-W5

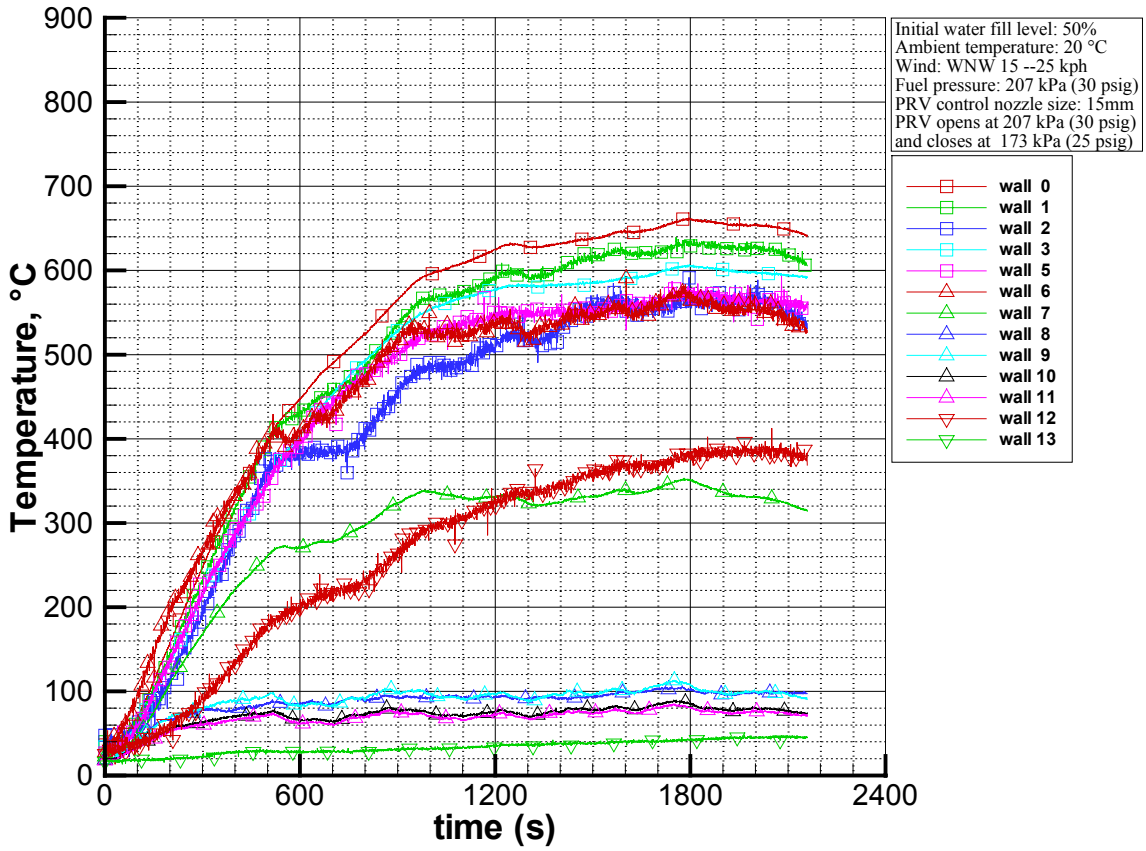
Figure 4.24: Wall temperature, Test 04-W5 (16% area insulation defect, 50% fill)

Figures 4.23 and 4.24 show wall thermocouple layout and temperature results, respectively. Wall temperatures under the jacket increased rapidly and by 730 seconds the wall was at 500°C. By 25 minutes the wall temperature under the jacket peaked at about 640°C. This was 20-40°C hotter than expected from simulations.

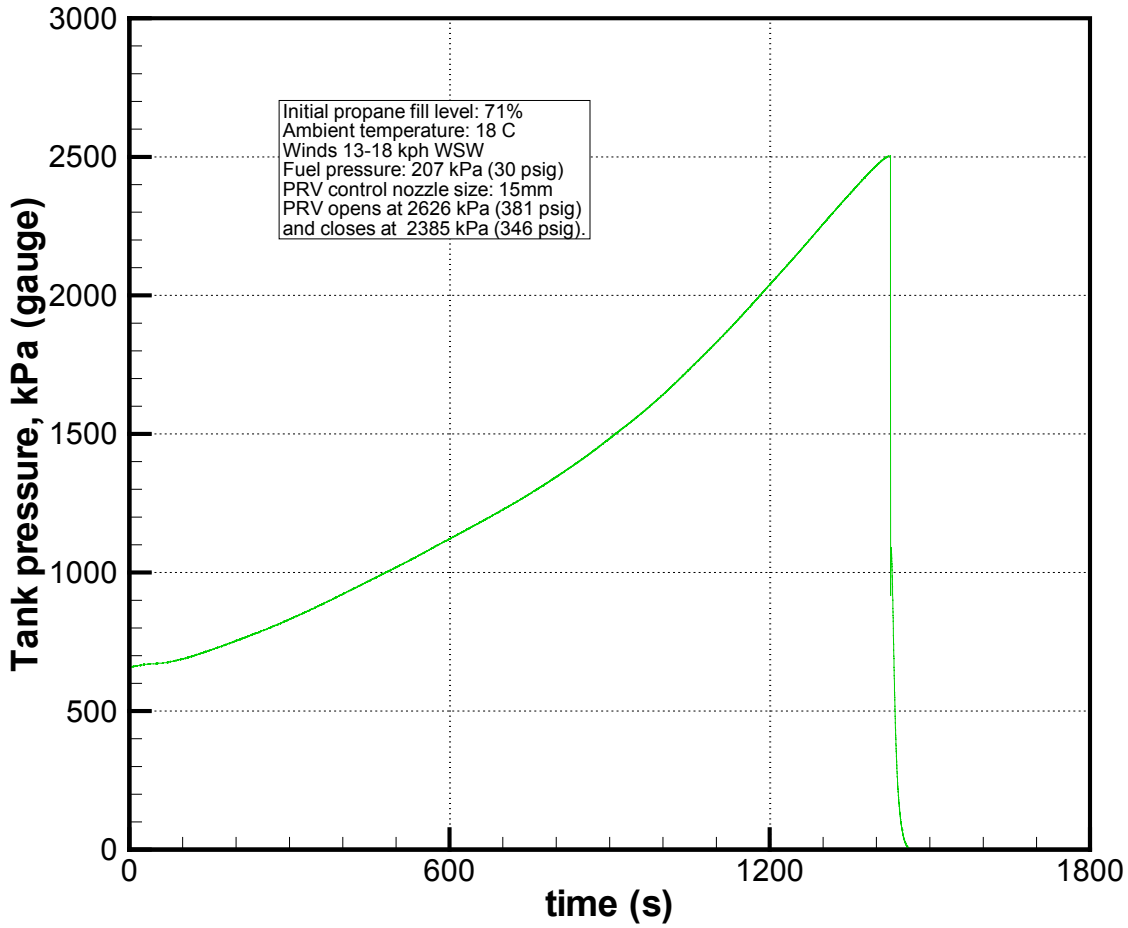
Figure 4.28: Tank pressure, Test 04-3

Tank pressure rose slowly due to the jacket and the 25% fire condition. By 700 seconds the peak wall temperature was 600°C. By the 1200 second mark, the wall temperature was 680°C. The tank failed at 1420 seconds (24 minutes). The tank pressure was about 2.55 MPa (370 psig) and the PRV never opened (Figure 4.28). It is expected the PRV would have opened at about 25 minutes.

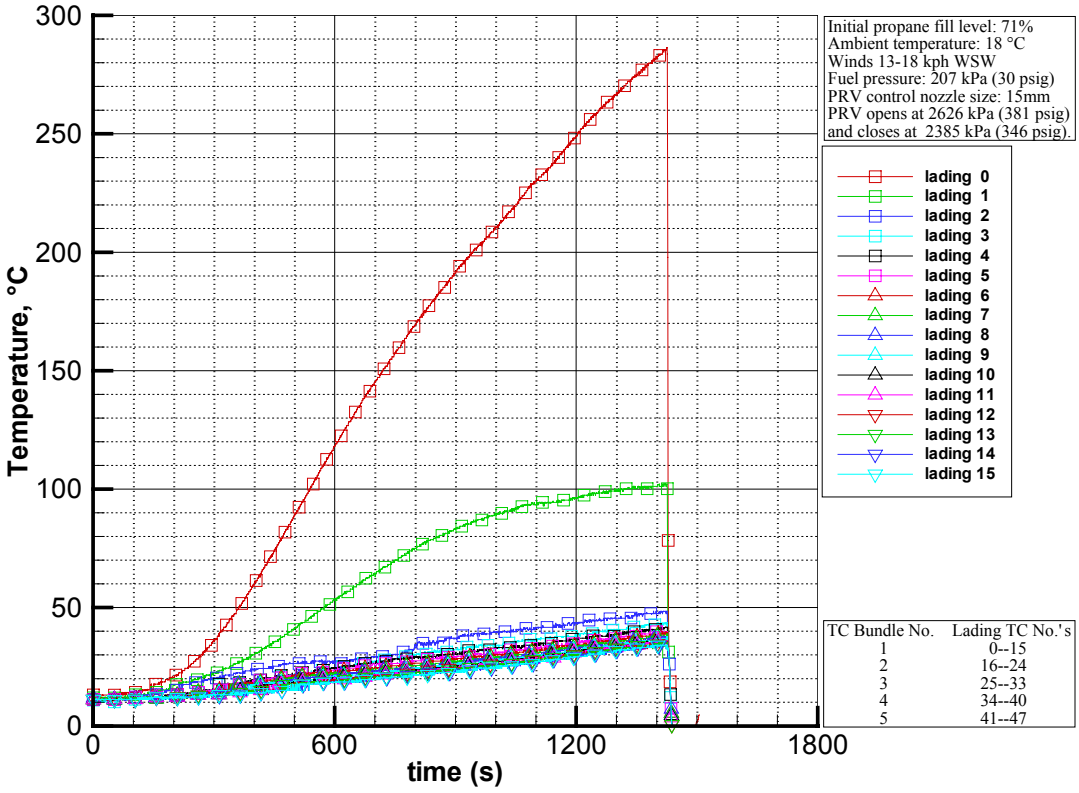
Figure 4.31: Lading temperature (TC bundle 1), Test 04-3

Figure 4.31 shows the lading temperature readings from the central thermocouple bundle. The liquid average temperature was only about 37°C at failure, well below the saturation temperature for the measured tank pressure at time of failure. The tank started at 71% full and 12°C. At 37°C, the fill should have been about 77% full by volume.

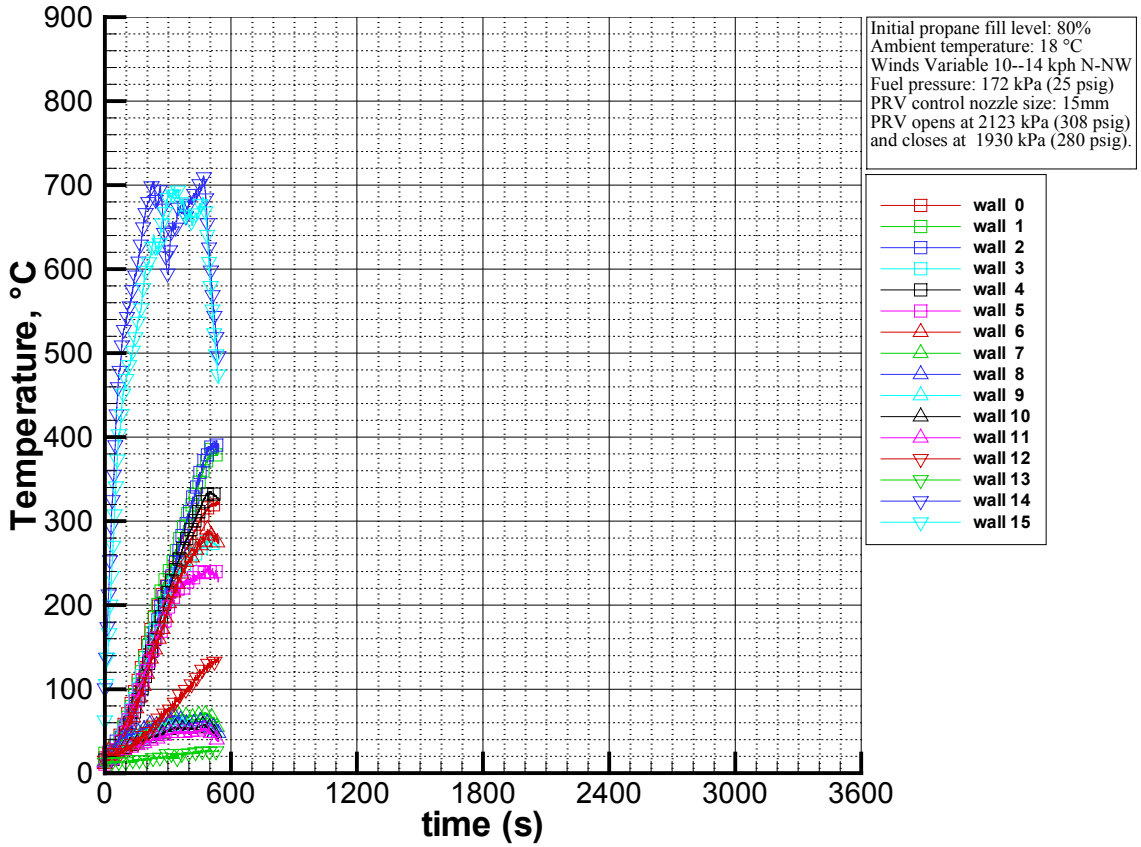
The test started at 11:39, but after 10 minutes, the fire was stopped because it was clear it was not hot enough. Figures 4.33 and 4.34 show the wall thermocouple layout and wall temperatures for this initial attempt, respectively. The jacket temperature did not exceed 700°C and it should have been around 800°C. The jacket temperature will rise rapidly to near the fire temperature. Fuel pressure was increased back to 206 kPa (30 psig) and the fire was restarted at 12:03. Figure 4.35 shows wall temperature readings that indicate the fire was then adequate.

Figure 4.34: Wall temperature, Test 04-4a (16% insulation defect, low hoop stress). Run aborted to increase fuel pressure

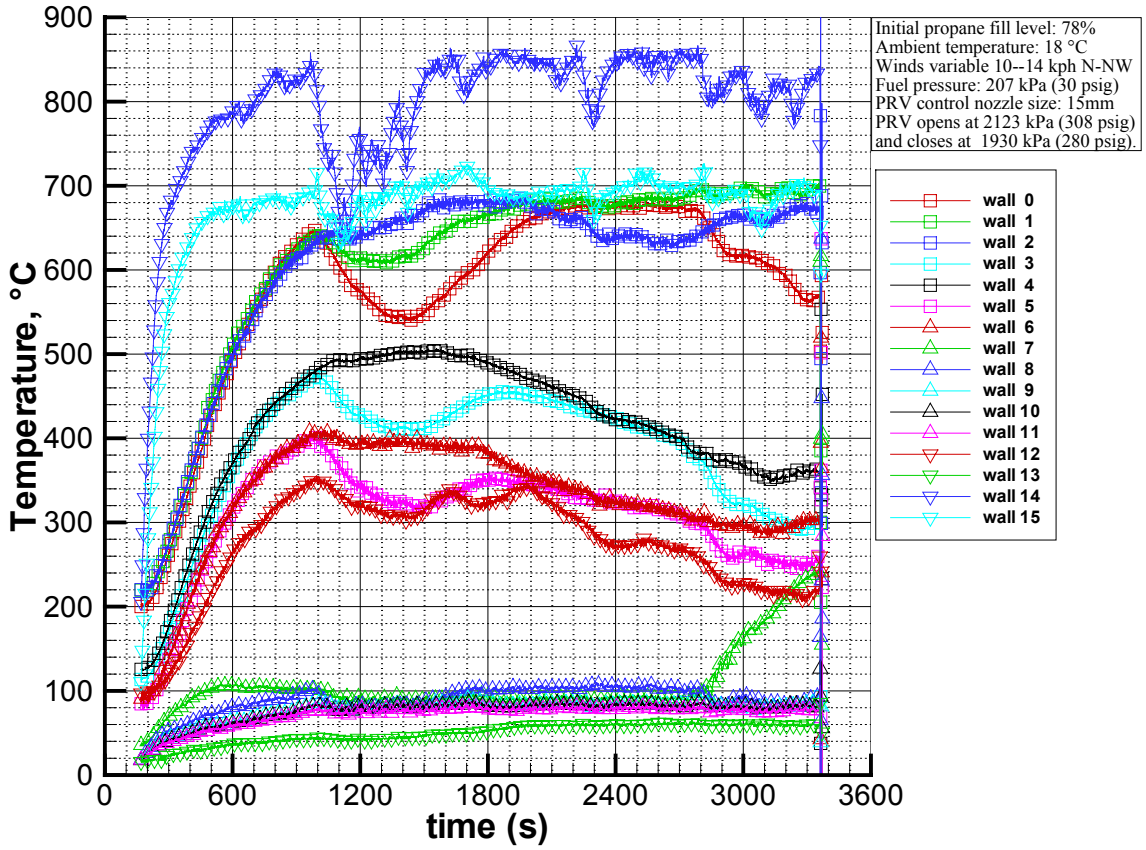
Figure 4.35: Wall temperature, Test 04-4b (16% insulation defect, low hoop stress)

The outer steel jacket temperature rose rapidly to peak at about 850°C, suggesting a fire temperature in the range of 870-900°C. The peak tank wall temperature levelled off around 680°C. For one period of about 8 minutes, the fire dropped below 700°C. The wind caused fluctuations in the fire, clearly seen in the jacket and wall temperature data.

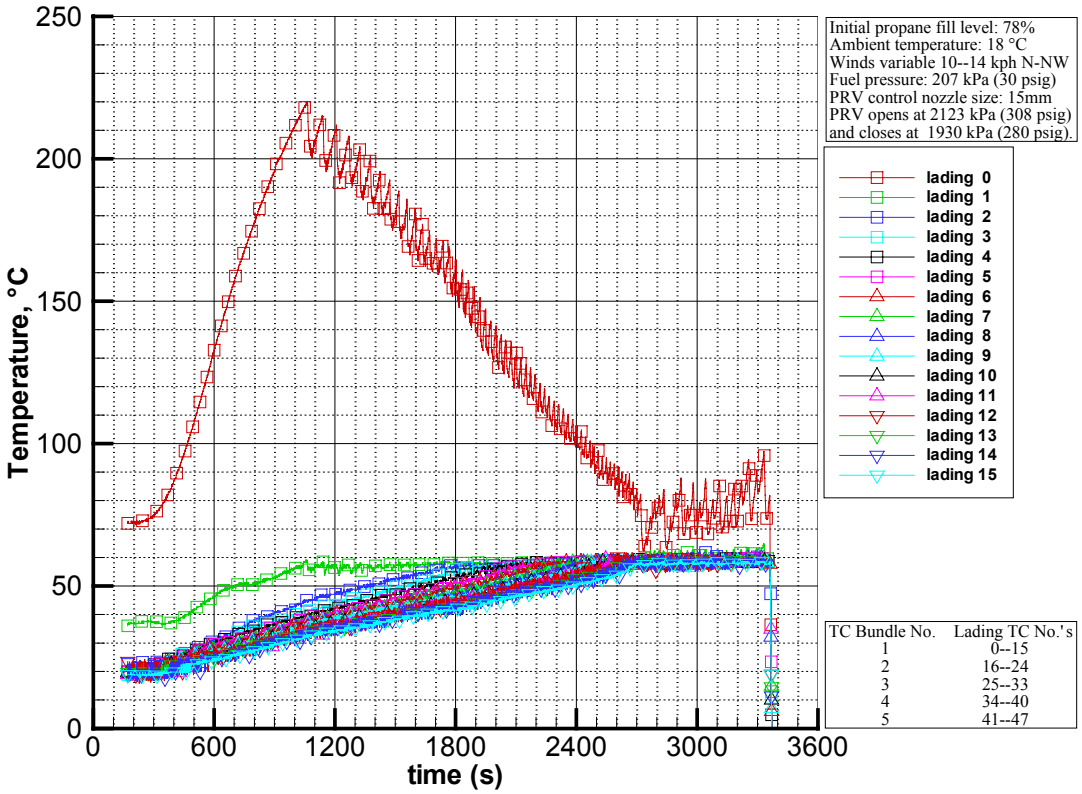
Figure 4.38: Lading temperature (TC bundle 1), Test 04-4

The failure was a jet release once again. Figures 4.36 and 4.37 show the tank soon after the jet release and the failure opening respectively. The lading was isothermal (Figure 4.38) and near the superheat limit, so there was a lot of energy available in the tank at the time of failure. It could well be that the jacket slowed the depressurization and suppressed the strong pressure transient that could have restarted the crack to give a BLEVE.

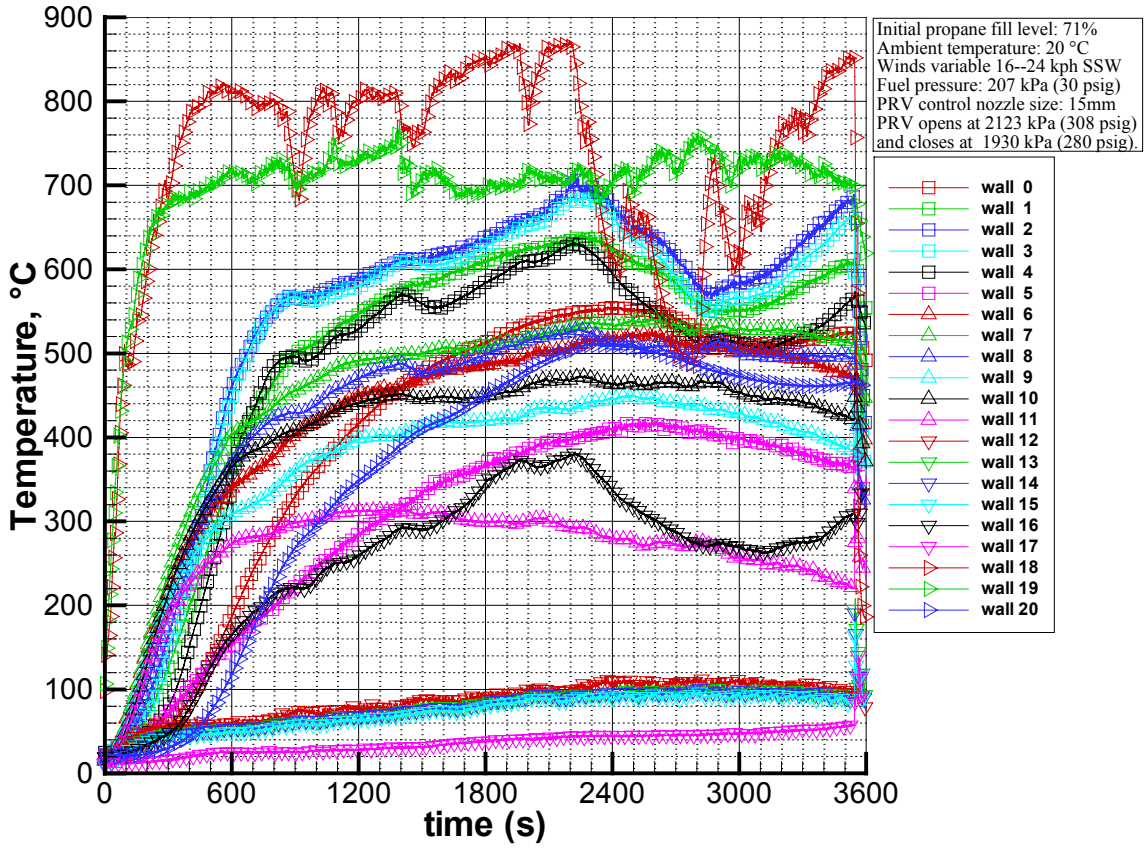
The test began with the wind 11 km/h from the SSW. The test started off well and by the 2000 second mark the jacket temperature was 860°C and the wall temperature was 700°C. Figures 4.39 and 4.40 show the wall thermocouple layout and wall and jacket temperature results, respectively. The wind then picked up and for about 1000 seconds and the wall and jacket temperatures dropped substantially. The wind then recovered and the test continued with rising wall temperatures. The tank failed with a minor rupture at about 3550 seconds.

Figure 4.40: Wall temperature, Test 04-5 (8% insulation defect). Flame lifted or shifted for approximately 1200 seconds of the test duration

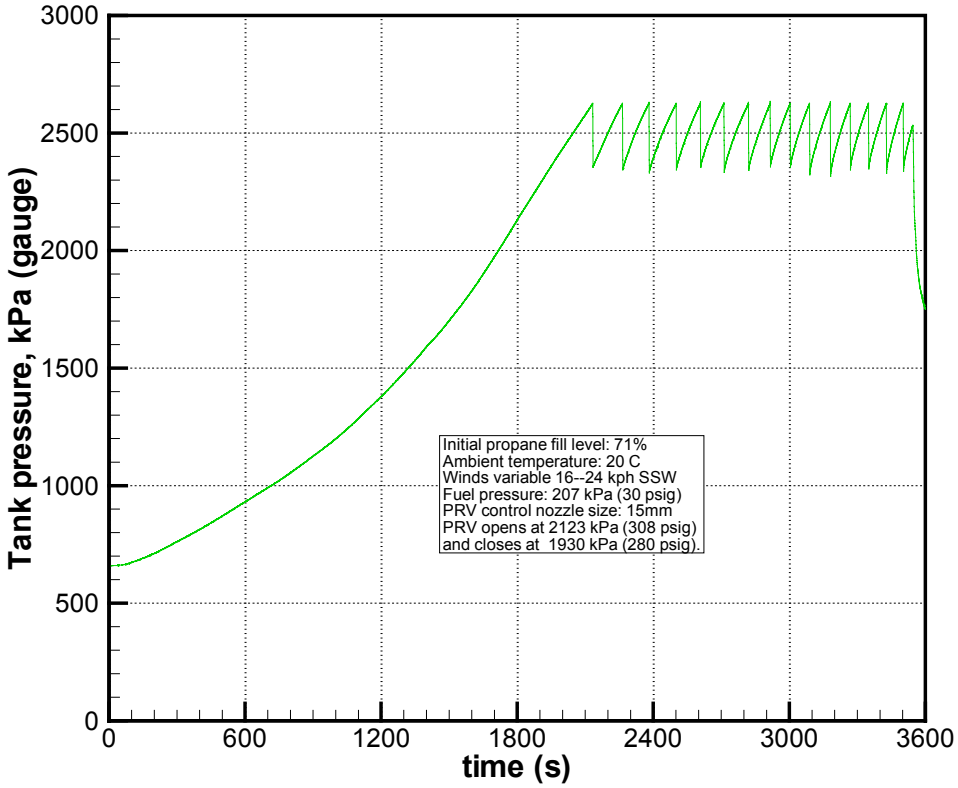
Figure 4.41: Tank pressure, Test 04-5

The PRV initially opened at 2130 seconds (35.5 minutes) and cycled 16 times (Figure 4.41) before the tank had a minor rupture. The split was so small the jet did not tear the jacket open (Figure 4.42). The tank was engulfed in a swirling fire from the leaking propane. After the tank had cooled and the outer steel jacket was removed, the tear opening in the tank wall was measured to be 64 mm long, with a maximum opening width of 2 mm. There was a vertical deformation of 51 mm from the surface of the tank. The tear was not large enough to effectively depressurize the tank, and the test was ended by dumping and burning the liquid propane.

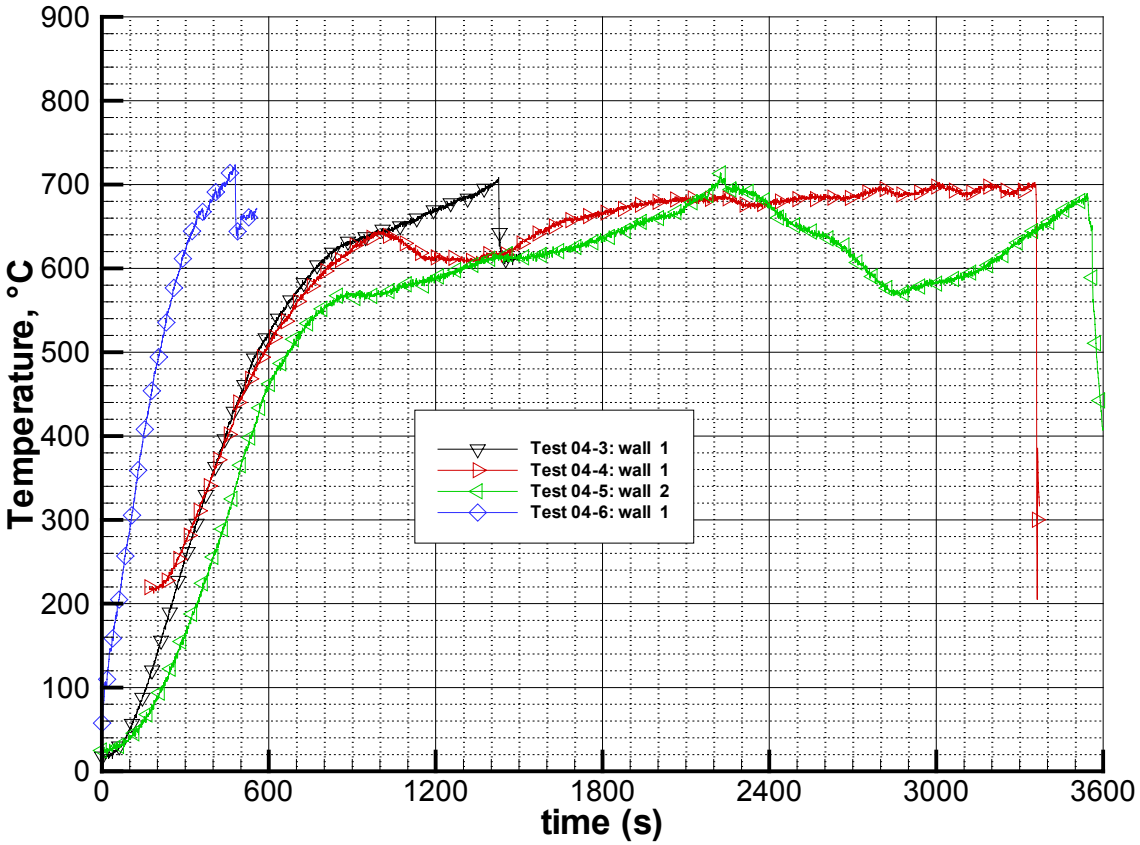
Figure 4.43: Tank wall temperature for tests 04-3, 04-4, 04-5, and 04-6 (thermocouple located at top and centre of the tank)

The peak wall temperature data in Figure 4.43 show the expected trends for the data set. The baseline (no protection), Test 04-6, has the most rapid wall heating, followed by lower heating rates for the large insulation defect cases, Tests 04-3 and 04-4. As expected, the lowest heating rate was seen with the small insulation defect, Test 04-5. The plots clearly show when fire intensities dropped due to wind effects. The two tests with 16% defect (high 04-03 and low 04-04 hoop stress cases) should have virtually the same wall temperature plots. The reason they do not is due to wind effects.

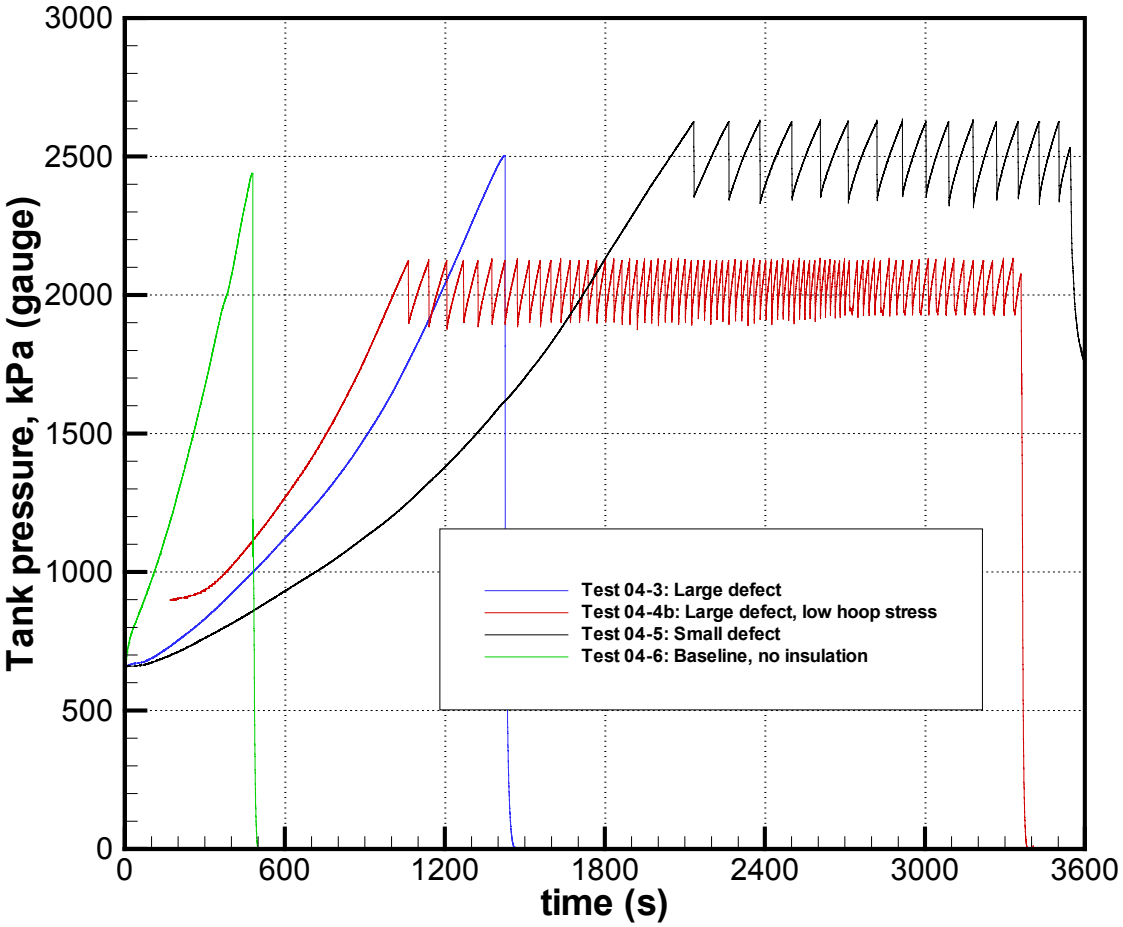
Figure C.2 shows tank pressure results for the four tests with similar fire conditions. The final rapid pressure drop for each data set indicates the point at which the tank shell fails. In the baseline and the large defect tests the pressure control system does not have a chance to cycle before the tank fails. Therefore, the tank fails with the initial fill mass of propane. The low hoop stress and small defect tests both exhibit a number of PRV cycles during the test period.

Figure C.2: Tank pressure versus time for tests with similar fire conditions.

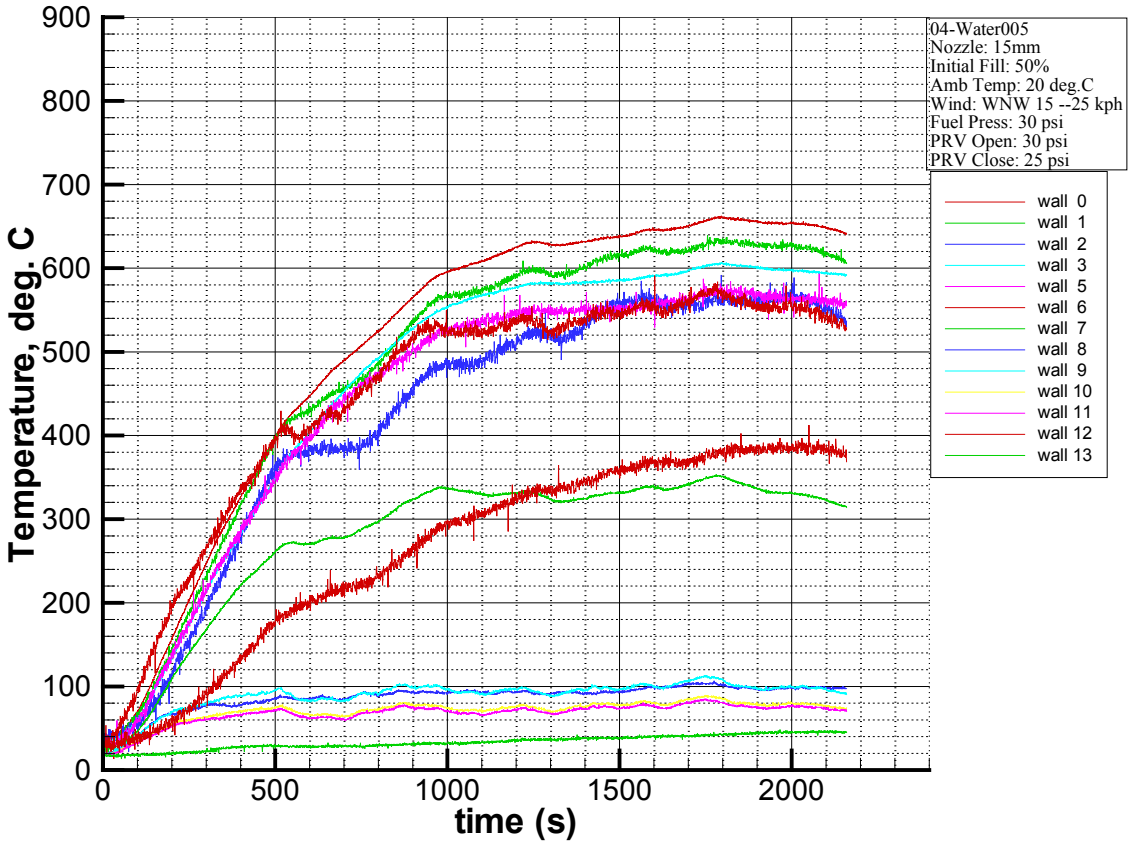
This water fill tank test considers the case of a 15% thermal protection defect. The defect was on one side of the tank and spanned from near the bottom of the tank to the top. The defect was 1.30 m wide and spanned almost the entire tank circumference except for the bottom 20-30 degrees. The remainder of the tank was insulated with 13 mm tank car ceramic fibre insulation. The white tank was painted black in the region of the defect to ensure a high emissivity.

Figure D.12: Wall temperature, Test 04-W5 (Water tank test, 16 % area defect, 50% fill).

The wind was strong during this test, 16 – 24 km/hr from the west and south west.

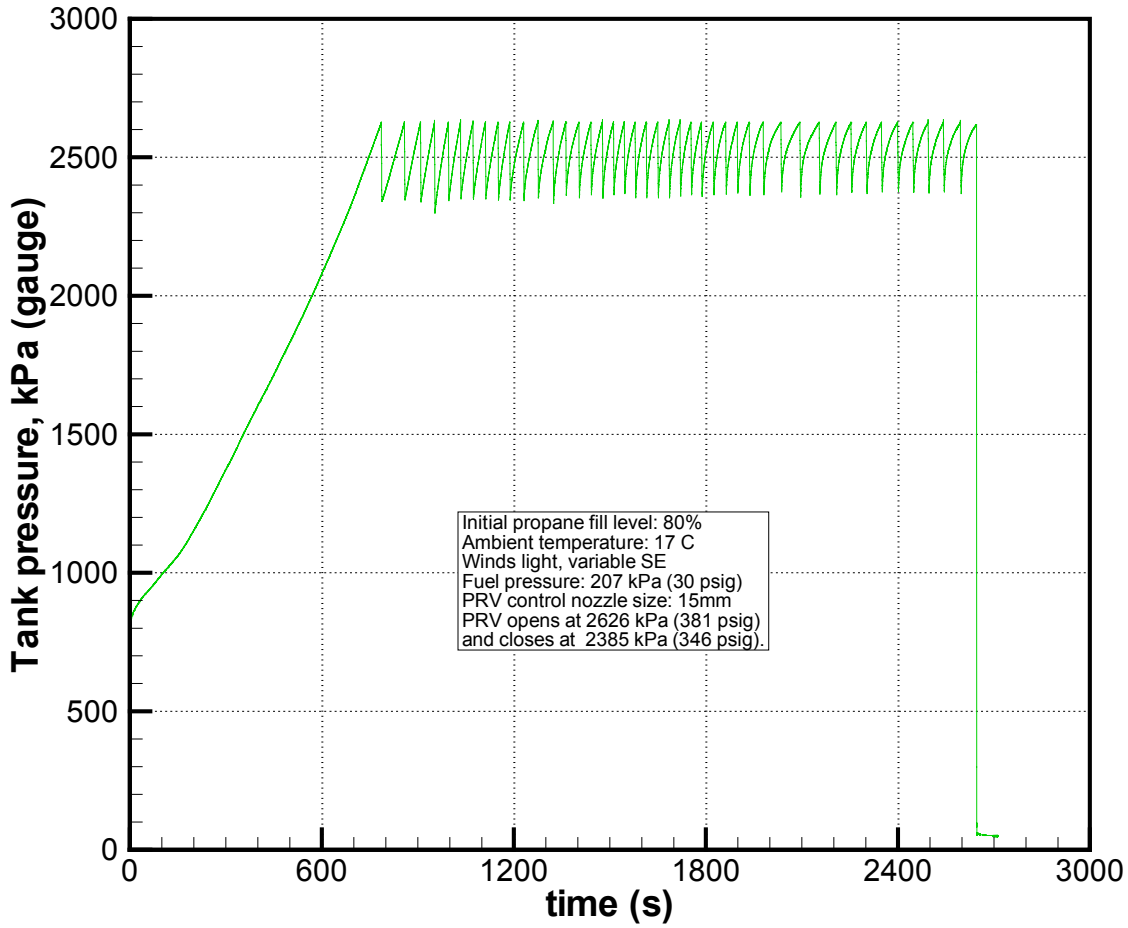
- Baseline
- No steel jacket or ceramic fibre blanket insulation
- PRV setting: 2.63 kPa, 9% blowdown
- Fill level: 78% initial, 70% at failure
- Strong BLEVE
- Failure at 44 min (11 min adjusted time)
- Fire and wind conditions were not acceptable, discard test as baseline

Tank pressure, Test 04-1 (baseline, no insulation).
